**Phase I Environmental Site Assessment
Undeveloped Land
711 Ogden Avenue
Lisle, Illinois 60532**

EASE Project Number 0596-0213-SA

Initial Preparation: July 19, 1996
Revised: April 1, 1997

Environmental Associated Services & Engineering, Inc. (EASE)
8210 42nd Street West
Rock Island, Illinois 61201
309-787-4048

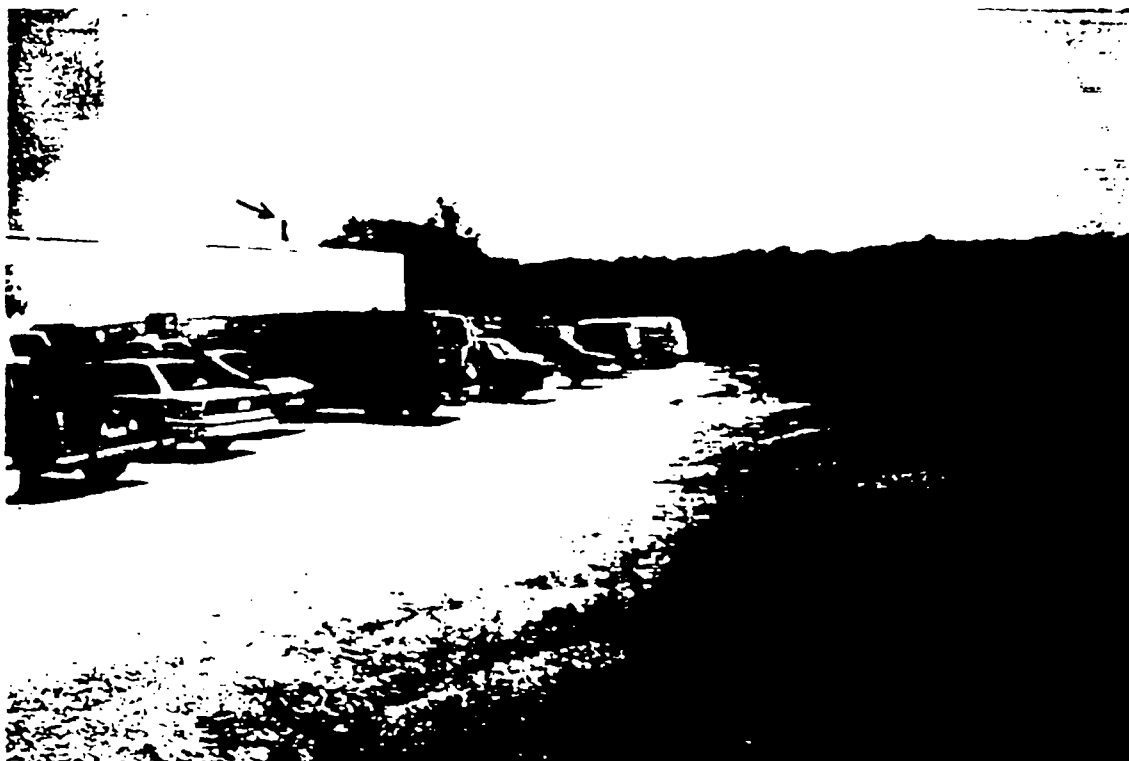
1. Roof top mounted storage tank on Lockformer building
2. Miscellaneous stacks on Lockformer building. No visible emissions.
3. Surface drainage of storm water from the Lockformer site is to the south on to vacant property. Site was dry.

Roof mounted trichloroethylene (TCE) storage tank. View is looking to the southeast from subject property.
